Subject: Heating and Blower Door Tests of the Rooms for the SIPA/Reiker Project

This draft report summarizes the construction features of the two test rooms built by SIPA. The conditions under which the heating and blower door tests were done and the results of them are then presented and discussed. The results of the comfort measurements are reported separately except for data on the stratification of air temperatures during the heating tests.

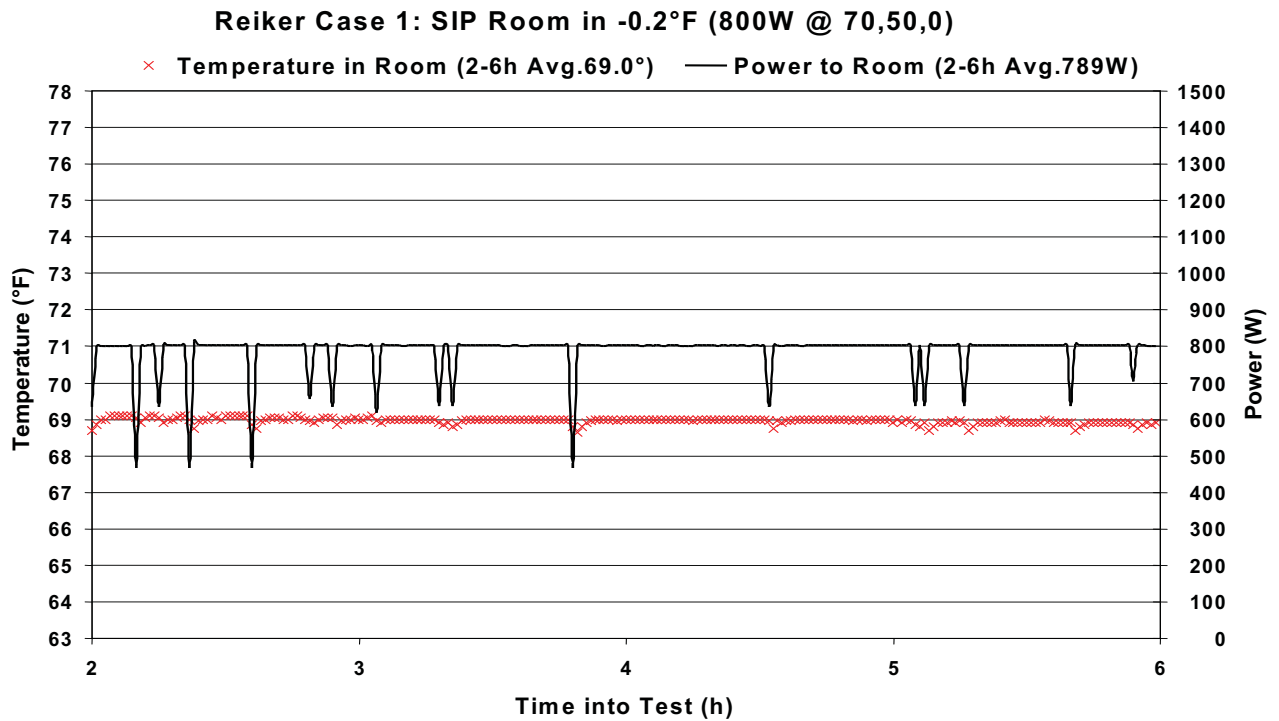
Figure 1. Example of Variation in Air Temperature and Heating Input Power for the Reiker Room Conditioner in the Room from Structural Insulated Panels.

Inside air temperatures, reported as the 4 hour average in Table 1, were measured at a height of 46 in. from the floor. The average at this height, the air temperatures outside and below the room and the raw heating power were obtained over the respective four hour periods by simply averaging the data that were reported at one minute intervals. Figures 1 and 2 show examples for the Reiker Room Conditioner in the SIP Room and the baseboard heater in the wood-framed room, respectively, of the time variations that are inherent to the inside temperature and raw power with the two methods of heating. The Reiker Room Conditioner clearly exhibits smaller fluctuations because its control method was more sophisticated than the one for the baseboard heater. The Reiker fan also generated considerably more air mixing within the test room space.

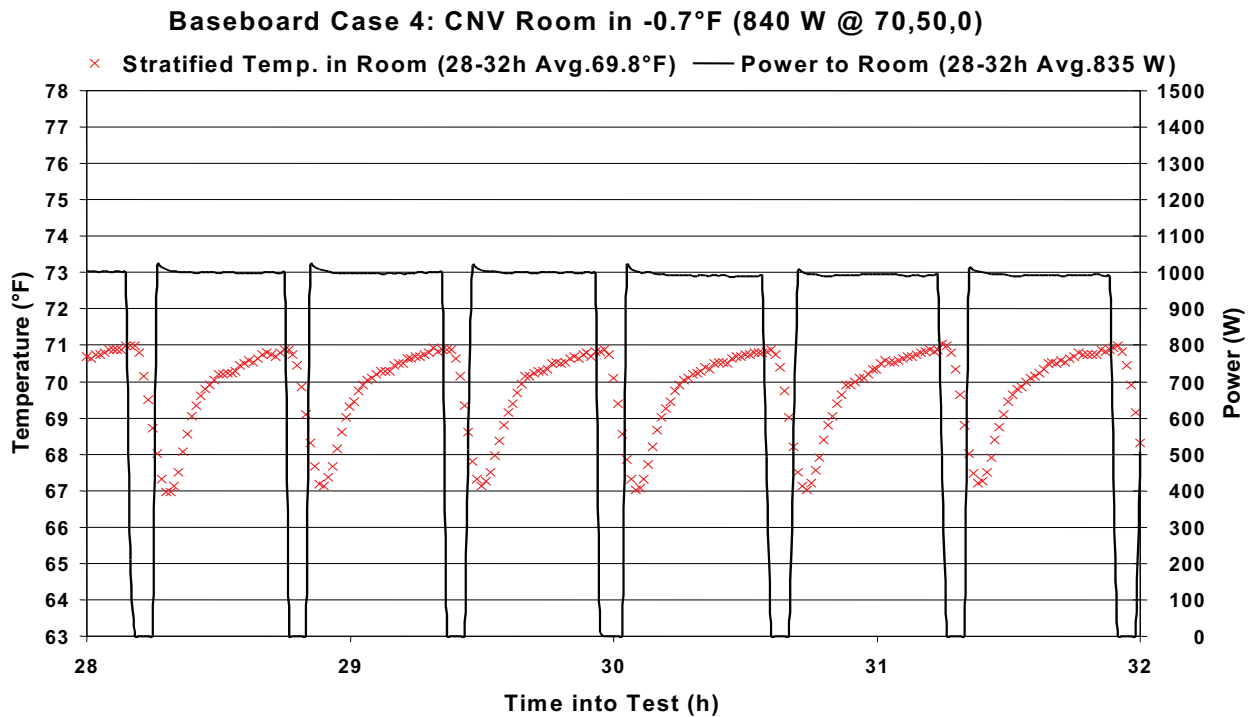
Figure 2. Example of Variation in Air Temperature and Heating Input Power for the Radiant Baseboard Heater in the Wood-Framed Room.

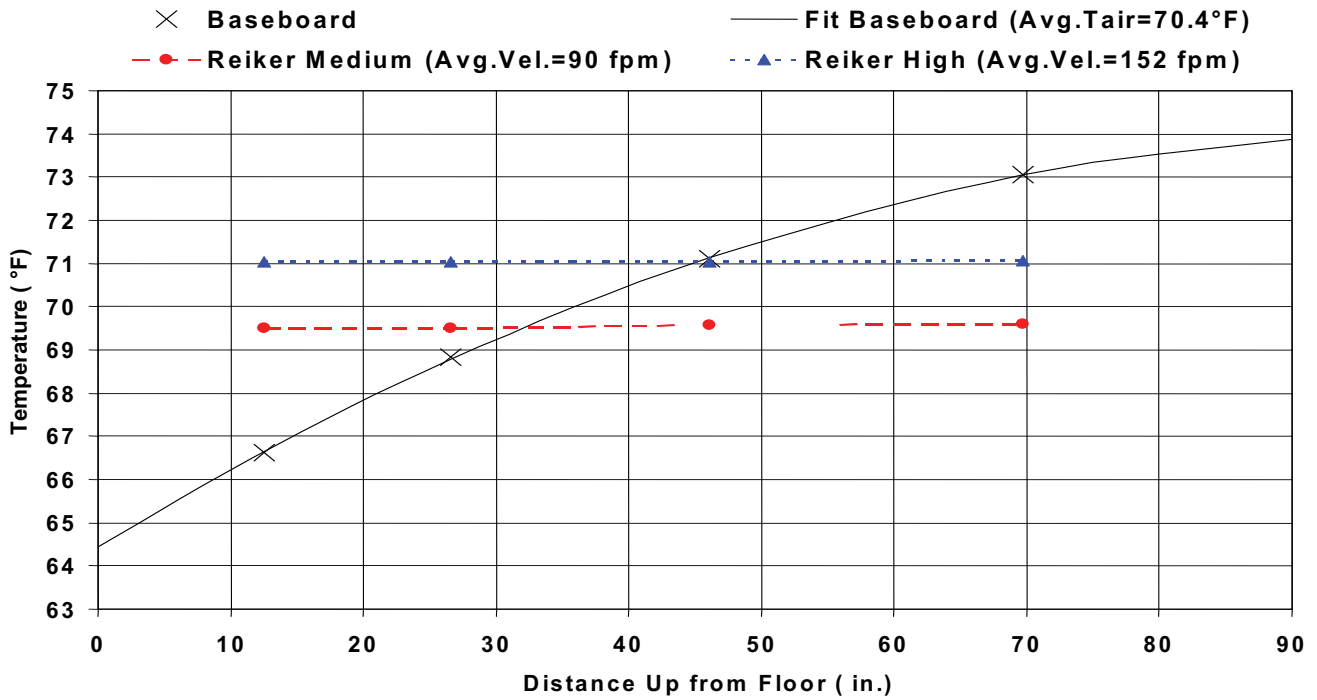
Figure 3. Stratification of Air Temperature from Floor to Ceiling of the Room from Structural Insulated Panels.

There is also a variation with height that is inherent to the inside temperature with the radiant-type baseboard heater. Figure 3 shows the significant stratification in air temperature from floor to ceiling with the baseboard heater and the complete absence of stratification with the Reiker Room Conditioner, in both the high speed fan and medium speed fan configurations for these tests. The average air temperature in the room with baseboard heating is 0.99 times the measured temperature at 46 in. above the floor. This small correction for inside temperature is included in the “Corrected Heater Power” data in the last column of Table 1.

In order to make cross comparisons it was necessary to adjust for the different vertical temperature stratification that resulted from each of the tests. The raw data was all adjusted to reflect inside uniform air temperature of 70 F. Heat losses through both the floor and walls were adjusted. The same floor was used in both rooms. Its air-to-air R-value was estimated to be 17.25 h·ft²·°F/Btu. Heat flow rate through the floor was calculated using this R-value and air temperatures 3 in. above and below the floor. For the baseboard-heated room, due to stratification, air temperature 3 in. above the floor was 0.914 times the measured temperature at 46 in. above the floor. Subtracting floor heat flow from raw heating power left heat flow through the walls, window, door and ceiling. An R-value was calculated for the room except for the floor using average air temperature in the room and outside air temperature. This is an experimentally determined value that averages out the effects of significantly different areas and R-values for the ceiling, walls, door, and window, as well as different infiltration rates.

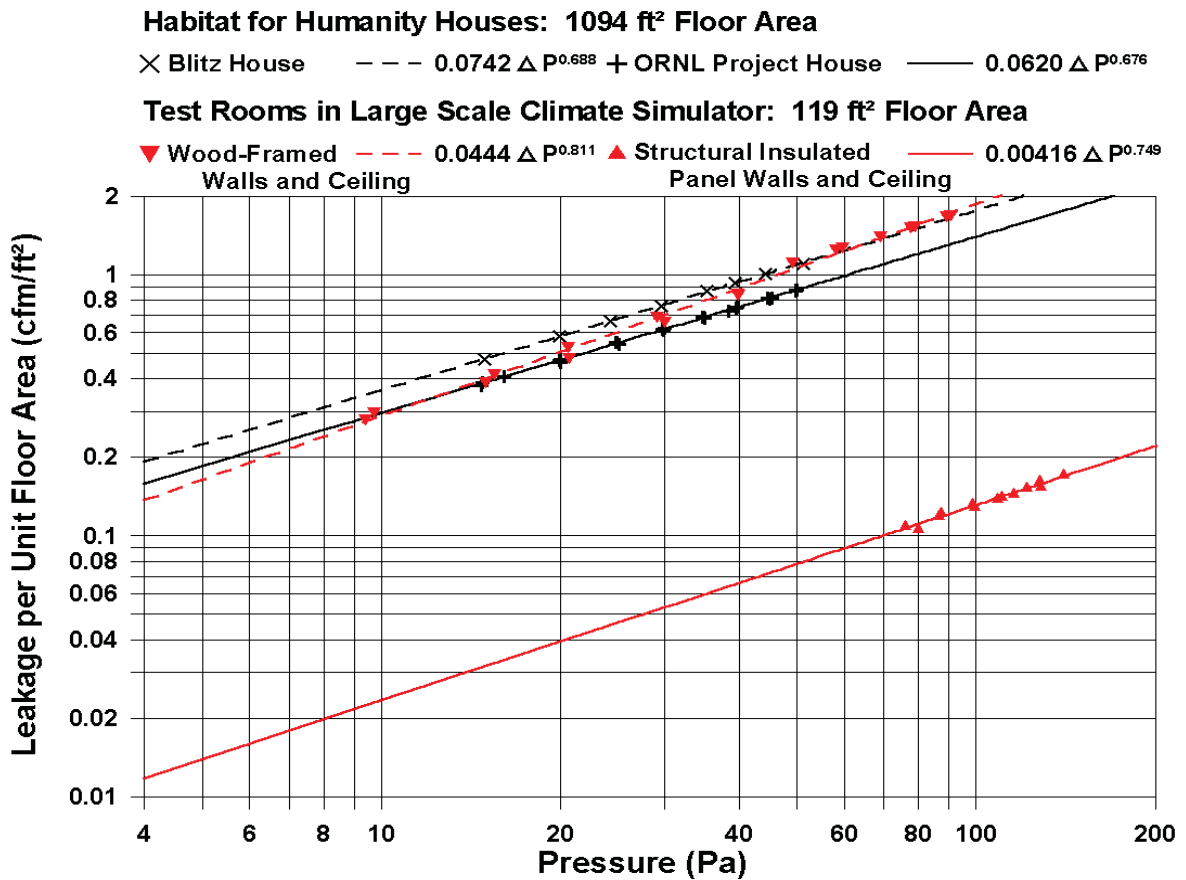
Figure 4. Blower Door Test Results for Whole Houses and the Test Rooms.

A common use of results from blower door tests is to estimate leakage area for wind-driven infiltration. One of the estimates of leakage area that is often used is the Lawrence Berkeley Laboratory effective air leakage area (LBL ELA) at 4 Pa. It extrapolates the results of the blower door tests to estimate leakage rate at 4 Pa. A smooth crack (discharge coefficient of 1) is then assumed and a calculation is made of the area to allow the leakage at 4 Pa. Figure 4 is a log-log plot of results of whole house blower door tests on two wood-framed whole houses with floor area of 1094 ft² and the current results for the 119 ft² rooms with no tape over room components (but the blower door enclosure well-taped). The results are extrapolated to 4 Pa by the equations shown in the legend.

The leakage per unit floor area for the SIP room compared to the wood-framed room retains the relationship shown in Table 2 that showed that the SIP room is almost 10 times less leaky. Leakage per unit floor area for the wood-framed room is very similar to leakage per unit floor area for the whole houses. The leakier of the two houses was a so-called “blitz” house for a Habitat for Humanity building project. A blitz house is built very quickly to get a project started with enthusiasm and could be expected to be leakier than one more carefully built. The other house was built for a side-by-side comparison to a house with a different exterior wall construction method. It could be expected that construction for it was done carefully so as not to prejudice the comparison.

Even though the leakage per unit floor area for the wood-framed room is about the same as for the two whole houses, the slope of the leakage with pressure is steeper. The values of the exponent for the wood-framed room and for the SIP room are larger than the 0.6 to 0.7 range that is usually seen with whole houses and is seen for the two Habitat for Humanity houses. This indicates that the cracks in these rooms present a longer path for air leakage than cracks in whole houses. A sharp sudden crack has an exponent of 0.5. A long path for a leak, like through a porous medium, has an exponent of 1.0.
